Track Session #3

Anomaly Detection/Characterization

-
- > PHMSA Government/Industry Pipeline R&D Forum
 - > June 24-25, 2009
 - > Washington D.C.
 - > by Daniel Ersoy, GTI

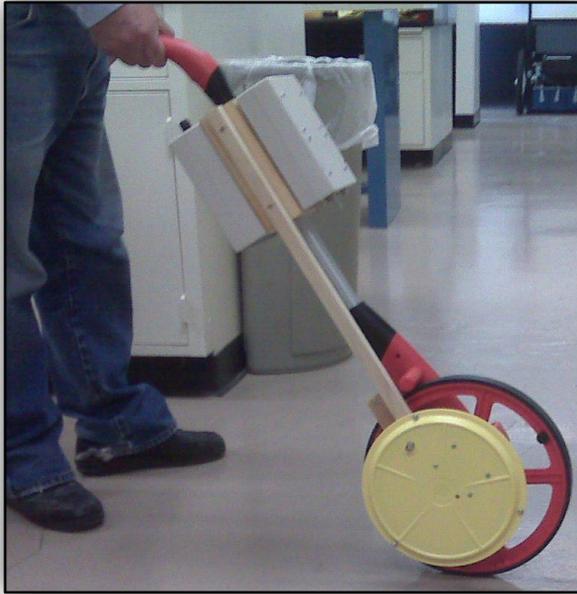
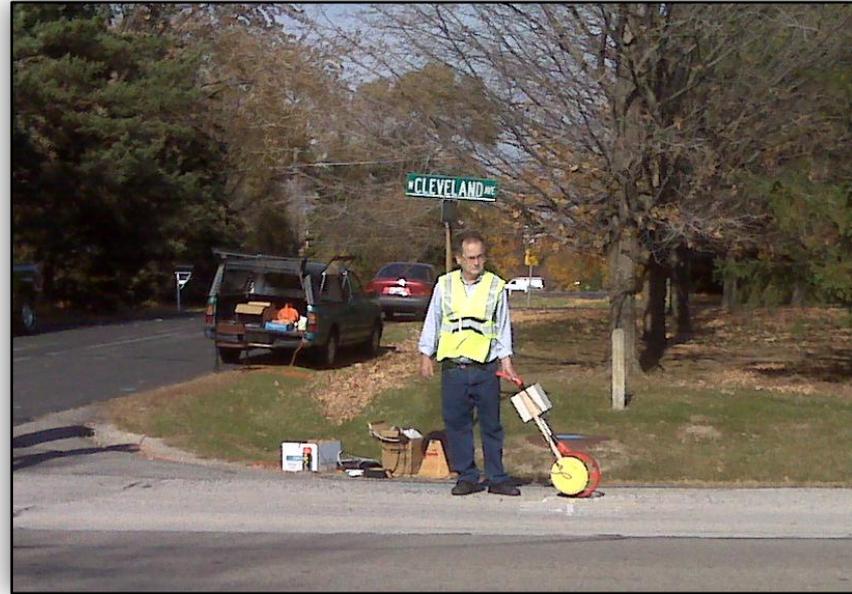
Disbondment Detector

Prototype captures magnitude, phase, and odometer reading.

- Completed a working prototype,
- Successfully tested on lab fabricated disbondments,
- Completed a 900 foot local utility pipe segment assessment.
- Excavations have shown disbondment detector has initial agreement with other above ground surveys and excavated condition (anomalies).

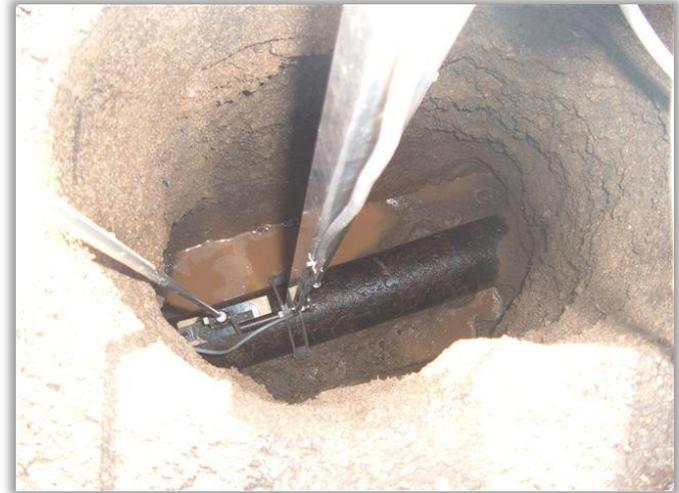
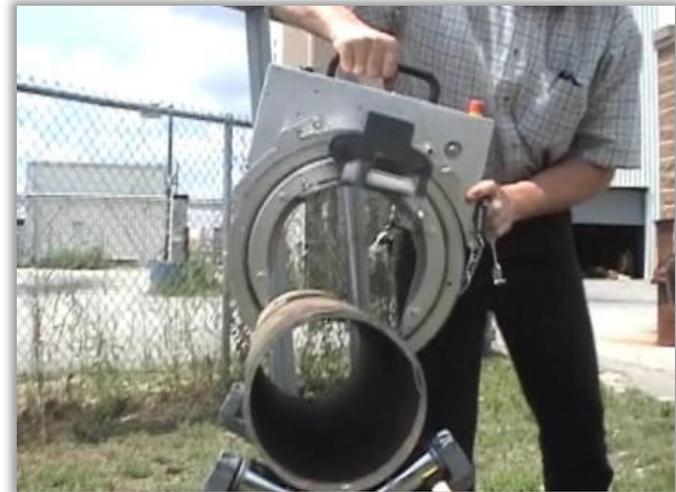
Broadband Electromagnetic (BEM) Inspection

- The BEM uses a magnetic field to induce a current in the pipe.
- These currents produce a decaying secondary magnetic field influenced by the pipe material.
- Analysis of this secondary magnetic field provides an indication of the state of the pipe (e.g., wall thickness).

- Measure wall loss on metal piping without the need to remove the coating, and
- Perform direct assessment examinations within a keyhole.
